Intel[®] Celeron[™] Processor Specification Update

Release Date: March 2001

Order Number: 243748-034

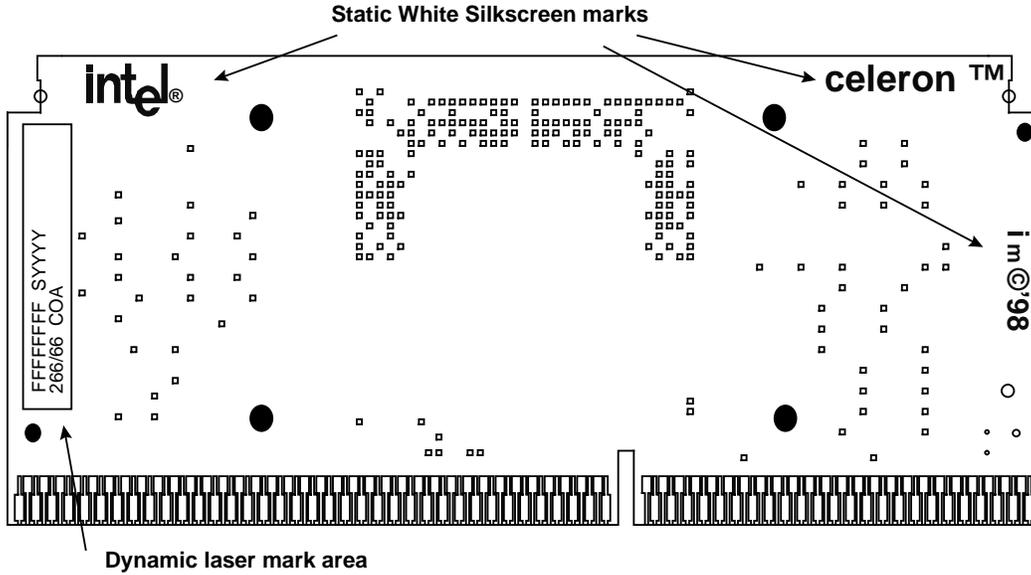
Intel® Celeron™ Processor and Boxed Intel® Celeron™ Processor Markings (S.E.P. Package)

- SYYY = S-spec Number.
- FFFFFFFF = FPO # (Test Lot Traceability #).
- COA = Country of Assembly.

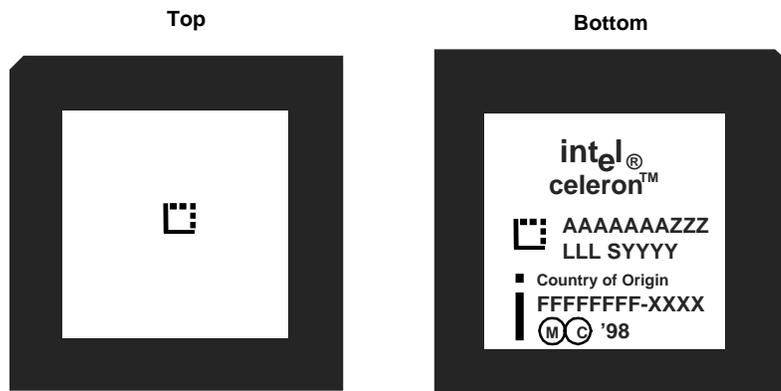
Intel® Celeron™ Processor and Boxed Intel® Celeron™ Processor Markings (PPGA Package)

- AAAAAA = Product Code
- ZZZ = Processor Speed (MHz)
- LLL = Integrated Level-Two Cache Size (in Kilobytes)
- SYYYY = S-Spec Number
- FFFFFFFF-XXXX = Assembly Lot Tracking Number
